Risk Assessment & Loss Prevention for LNG Ships

K.S. Wang
Principal Surveyor for Japan

Loss Prevention through Risk Assessment Surveys of LNG Carriers

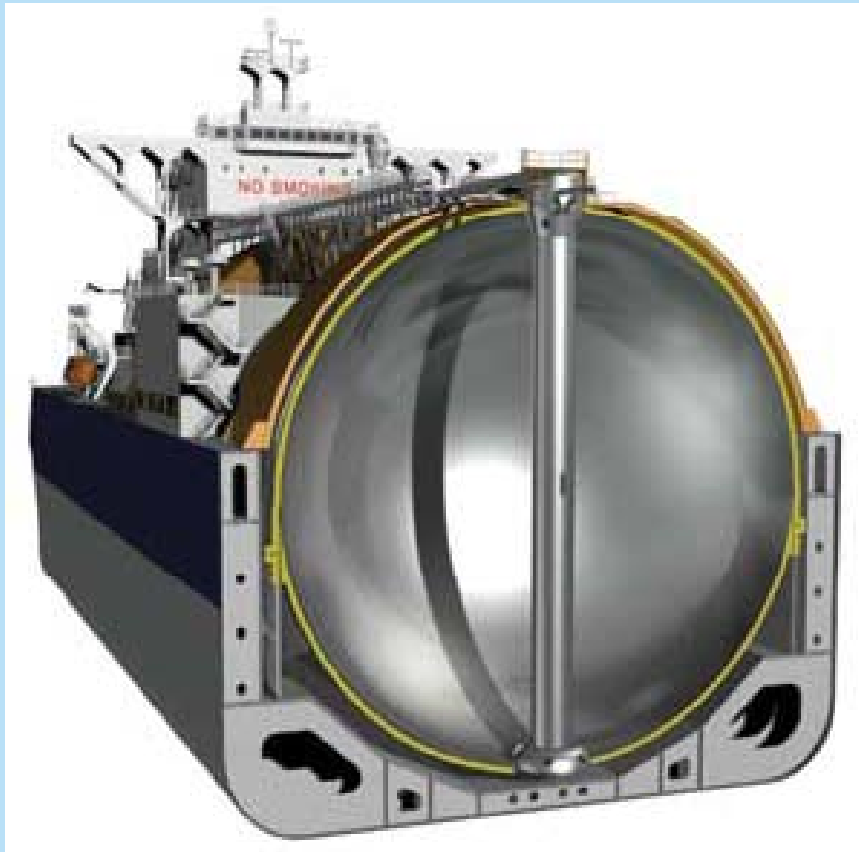
Moss Spherical Type of LNG Carriers

- Aluminum Alloy Spherical tank of 50 to 100 mm thick Aluminum Alloy plates.
- 40m in diameter.
- “Self Supporting”
- 40% of the world’s LNG carriers are of this type
- Smaller Collision and Grounding area

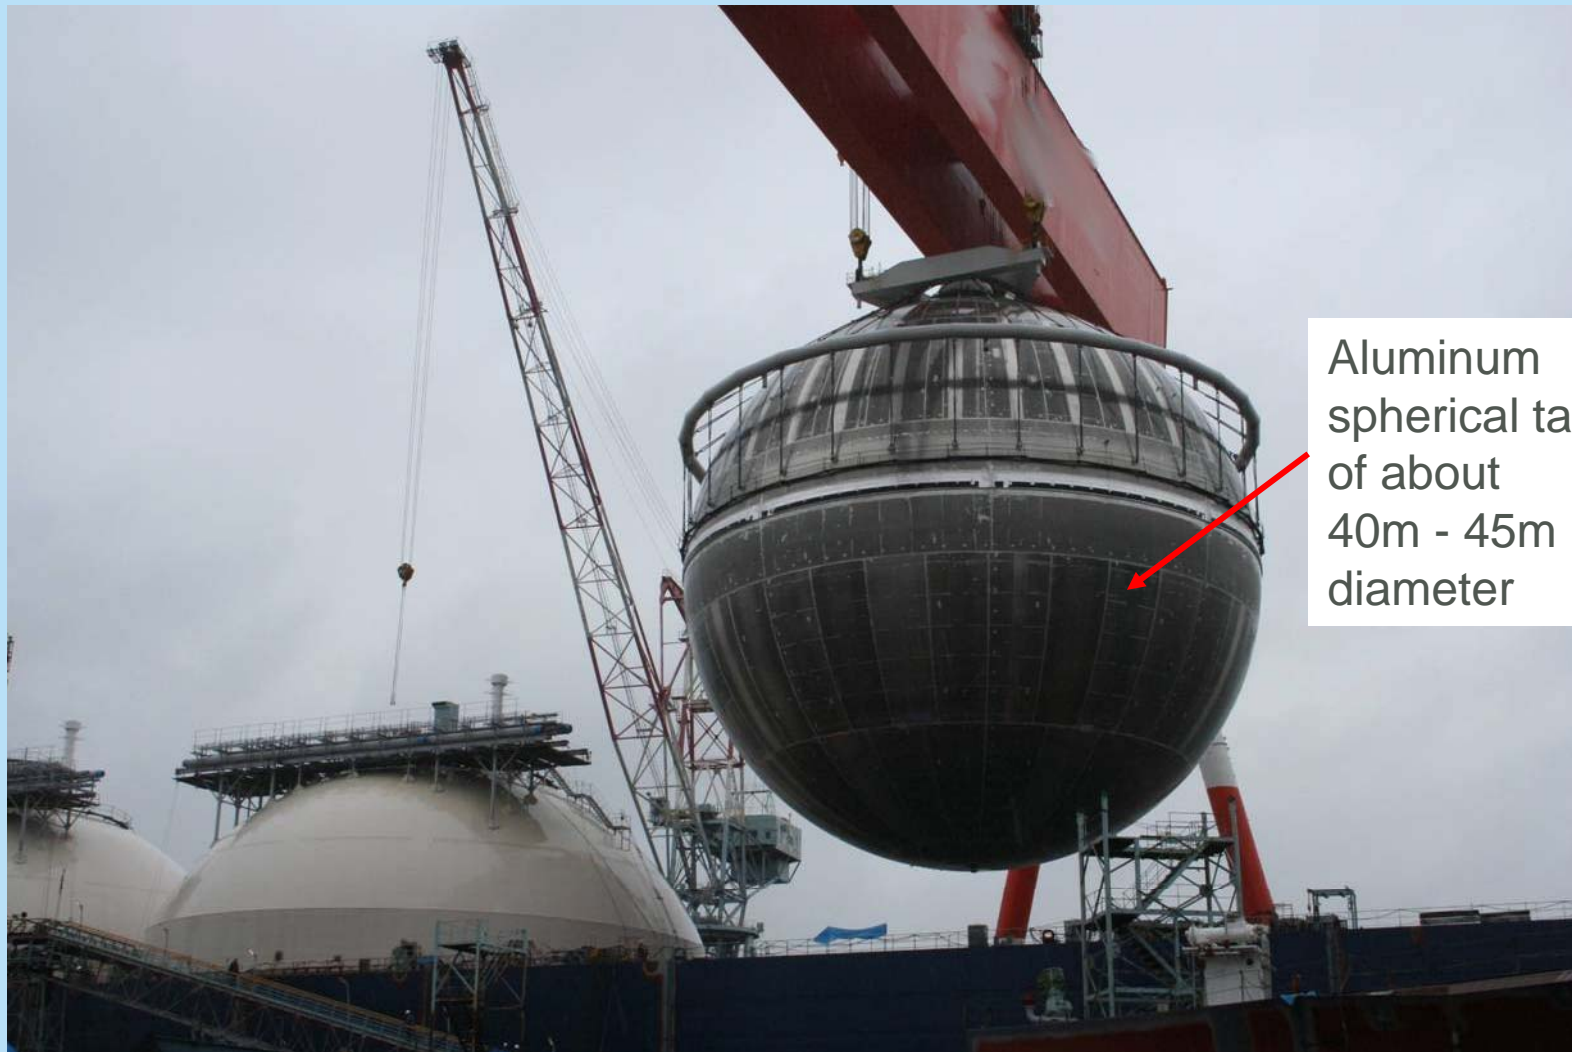
Aluminum
spherical tank
of about
40m - 45m in
diameter

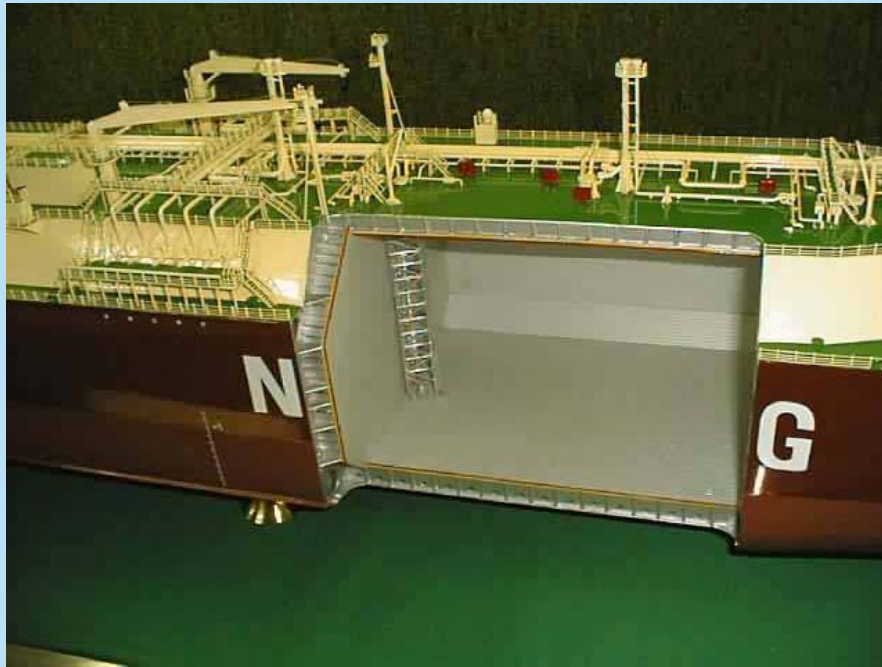
GTT MEMBRANE Type of LNG Carrier

- Primary membrane holds cargo.
- Secondary membrane prevents leakage.
- Primary & secondary insulation to maintain cargo temperature at -161°C
- Ship's hull to support tank.
- 80% of the world's LNG carriers under construction are of membrane type. Shorter building time in dry dock.
- More potential Collision and Grounding Contact Areas.
- Almost 60% of the LNG Carriers in the World.

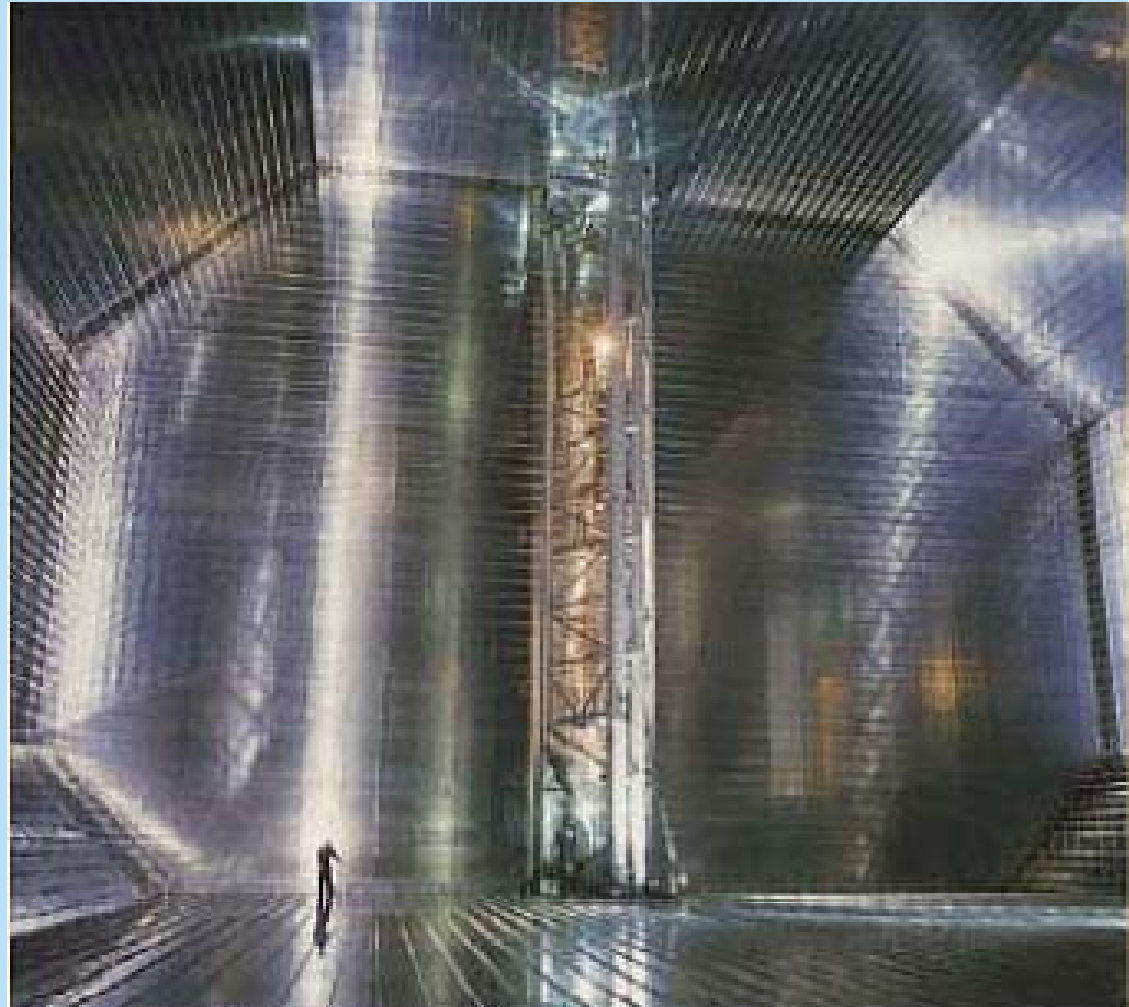
No.96 Membrane System of LNG Cargo Tank – Shining and Flat Surface

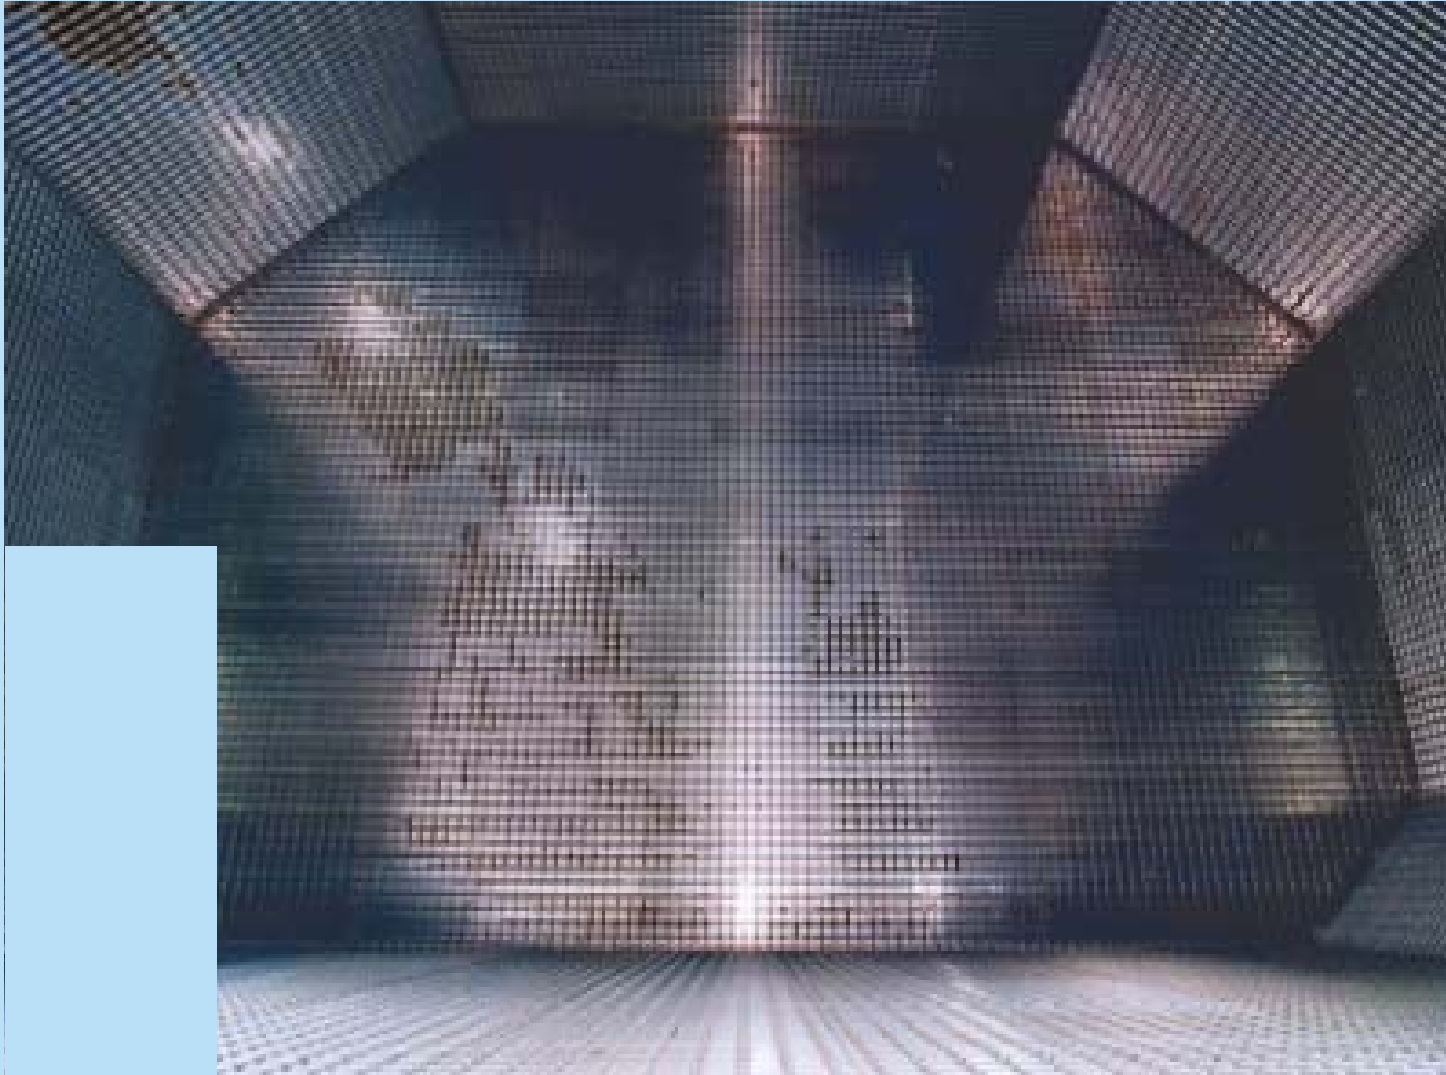
MARK III System of LNG Cargo Tank – Less Shining and Corrugated Stainless Steel Surface

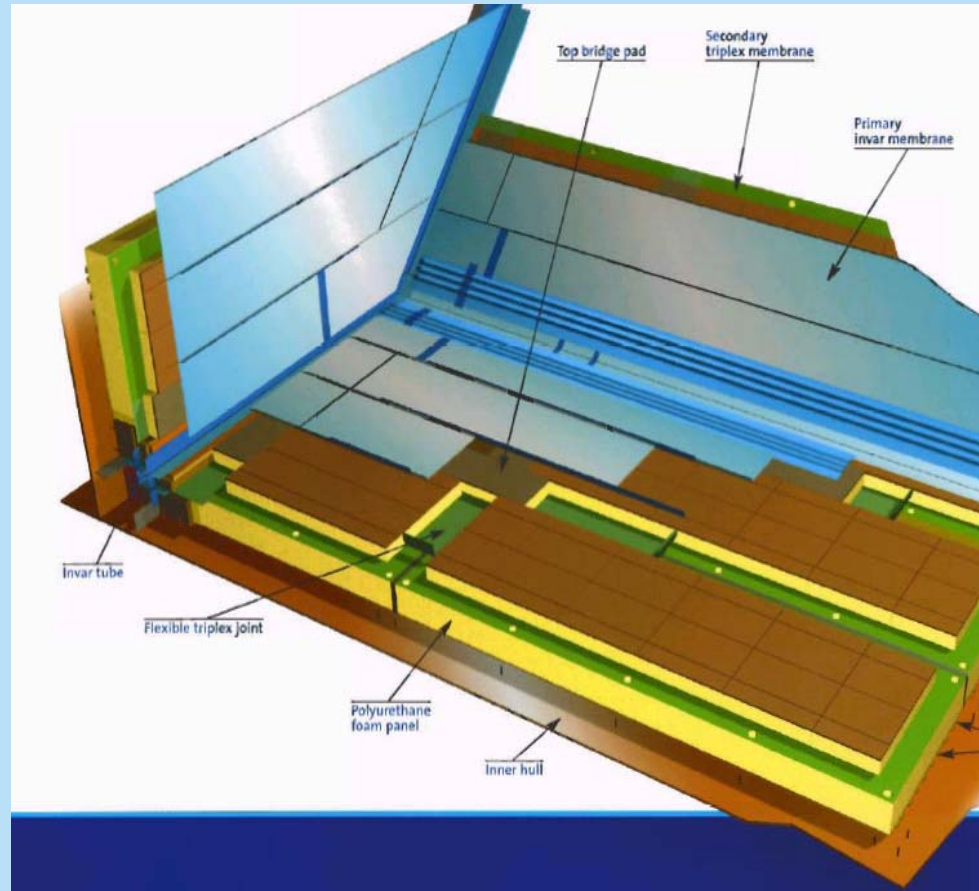
CS1 Membrane System

- New Design (Two ships in operation)
- Combination of Mark III & No. 96.
 - Nickel-steel (invar) (0.7 to 1.5 mm) primary membrane.
 - Glass cloth/Aluminum foil/Fiber Glass cloth Aluminum/glass “Triplex” secondary membrane.
 - Fabricated Polyurethane insulation panels with “Triplex” from workshop
 - Glue problem occurred at Secondary Membrane on 1st Ship

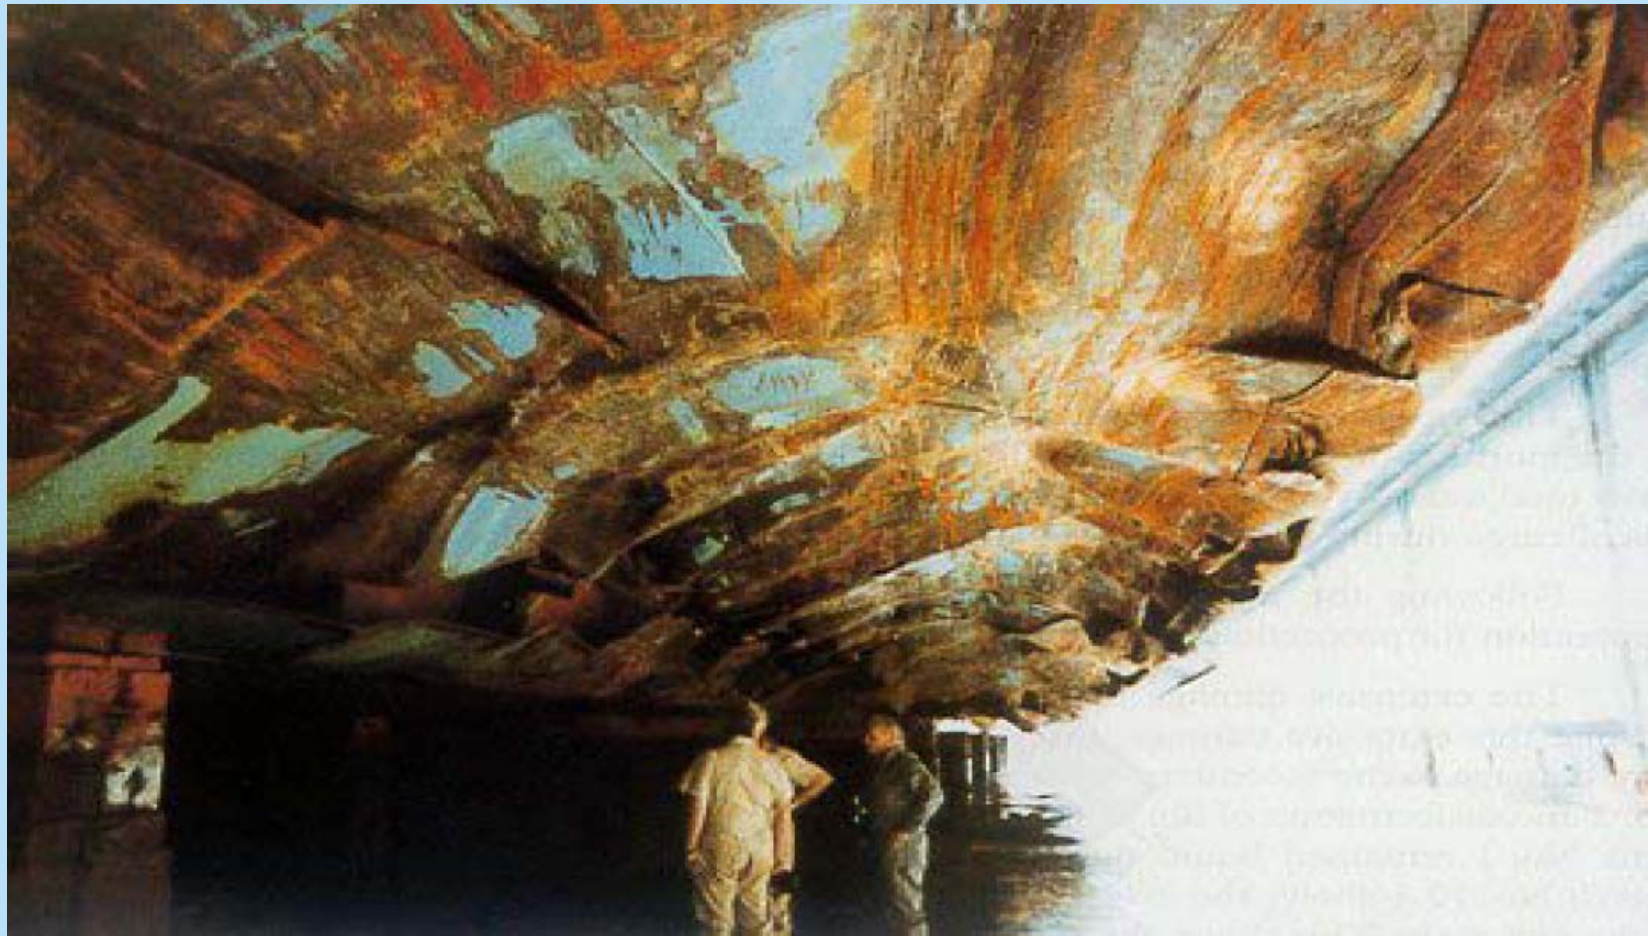
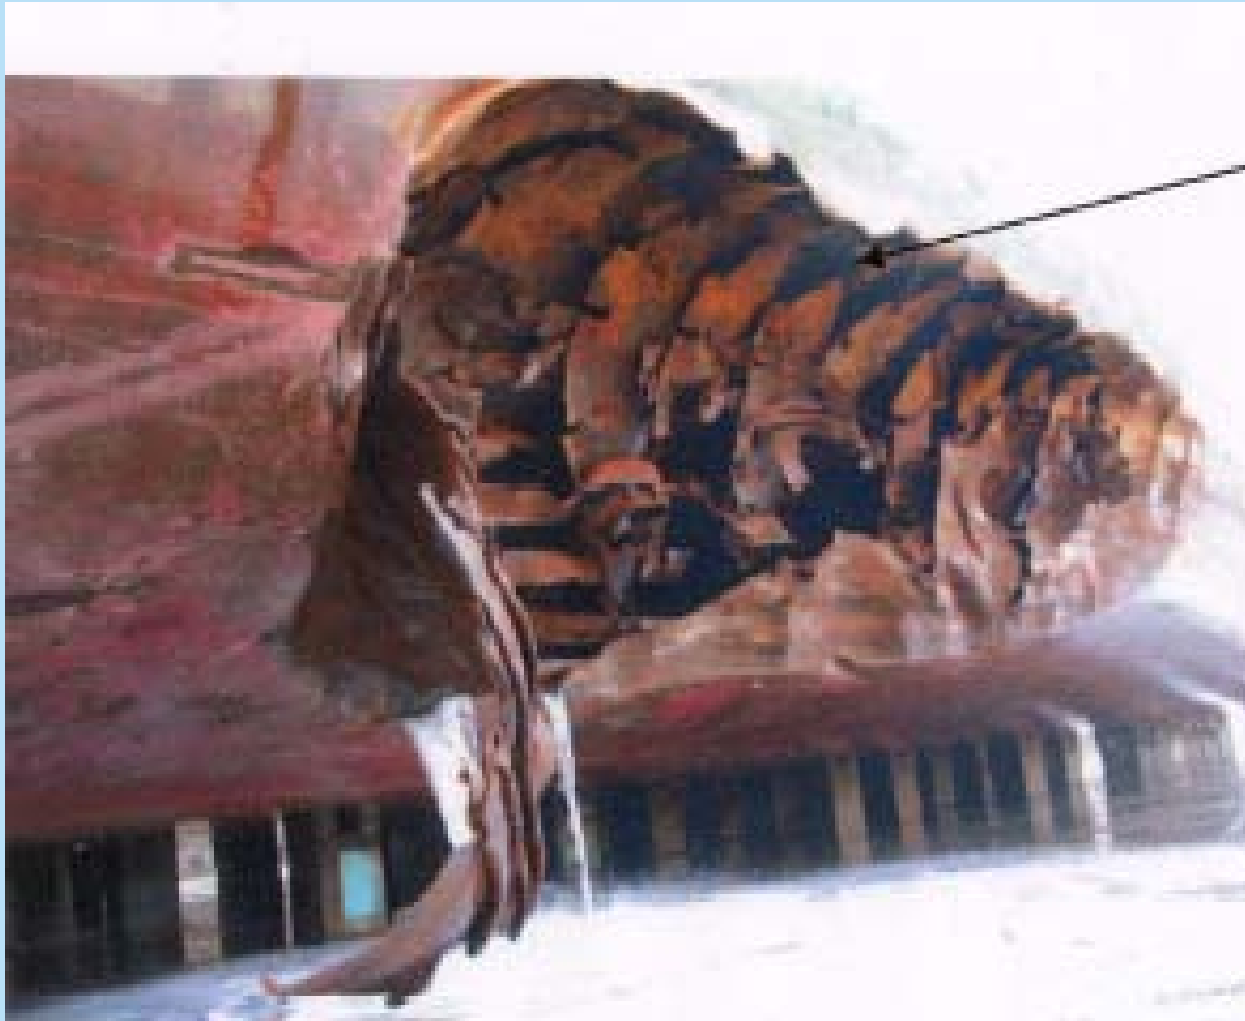
1980 LNG “X” grounding at Gibraltar – 2,500 tons of steel and deformation of cargo tanks: 1 ½ years of repair and 1st ship to ship transfer of LNG in history

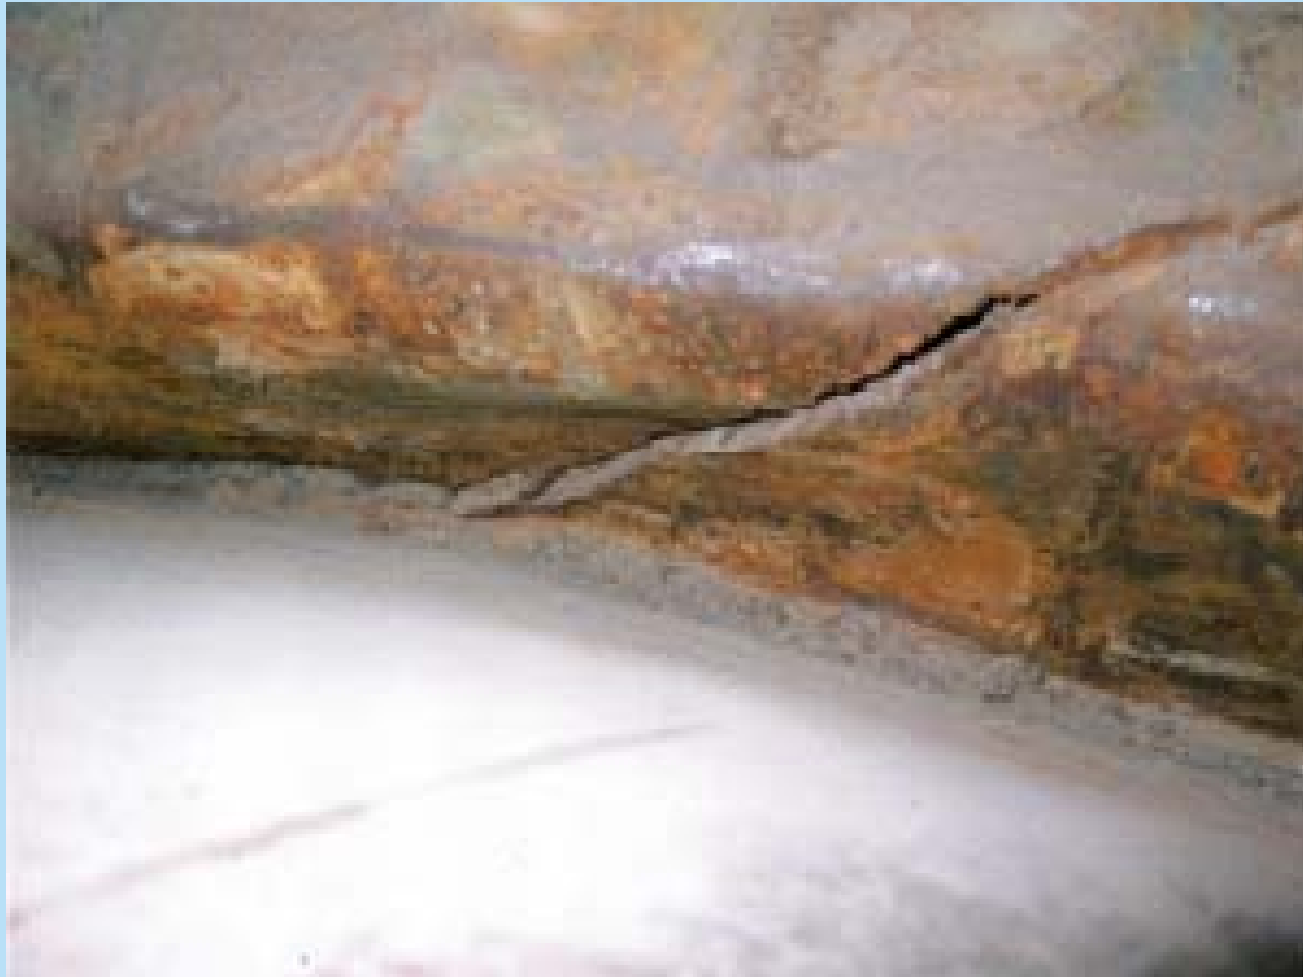
2004 - LNG “Y” grounding in Korea due to navigation error— 200 tons of steel, 8 months of repair and Millions \$

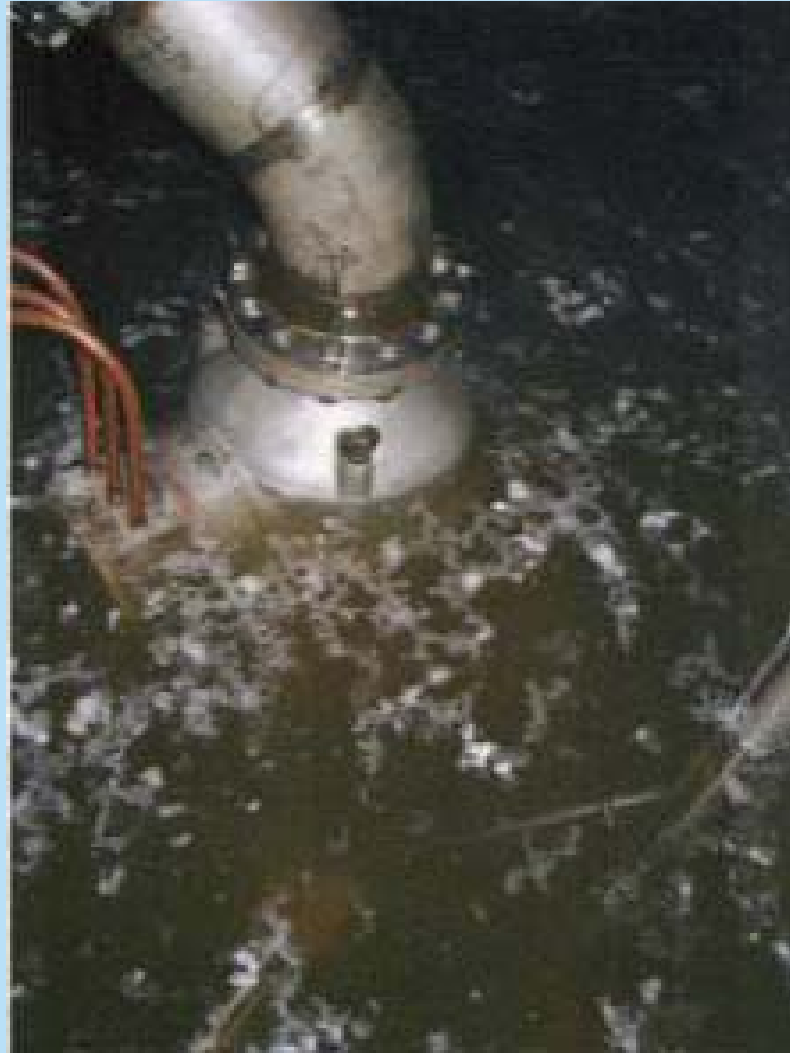
A minor crack (less than 1 meter long) due to grounding impact on the steel bulkhead in a cofferdam between No. 1 and No. 2 cargo tanks caused sea water ingress into No. 1 cargo tank

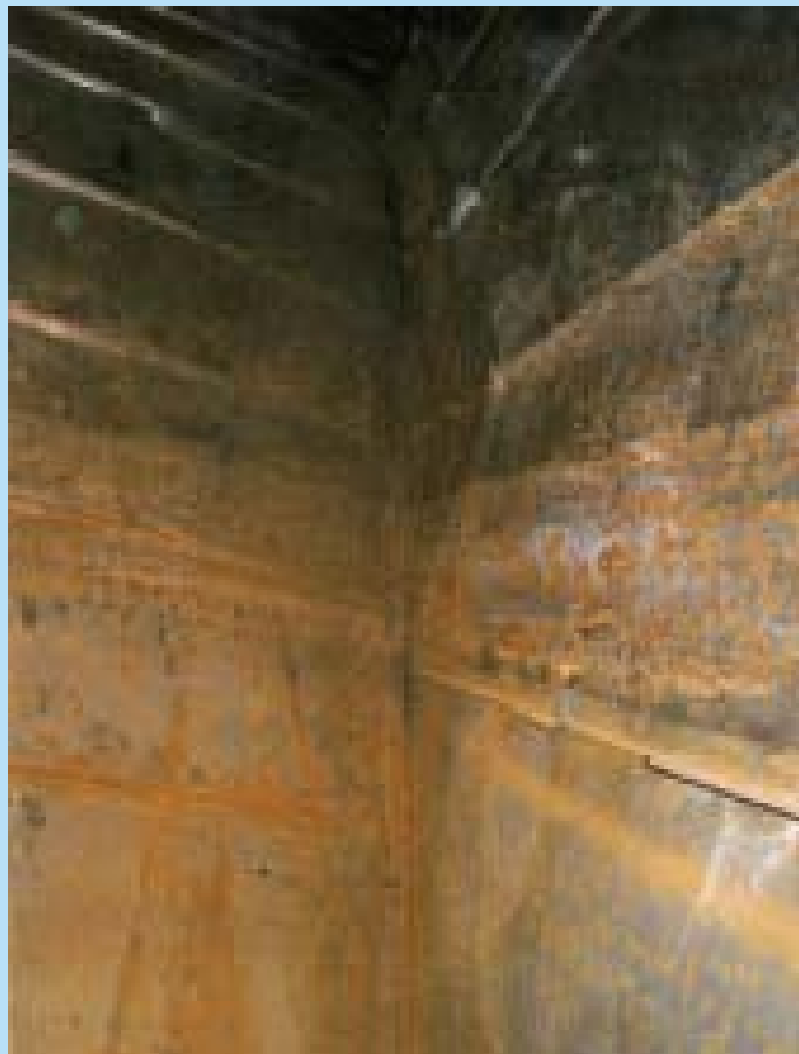
Result: Seawater ingress into cargo tank and LNG Cargo
Pumps Immersed in Seawater

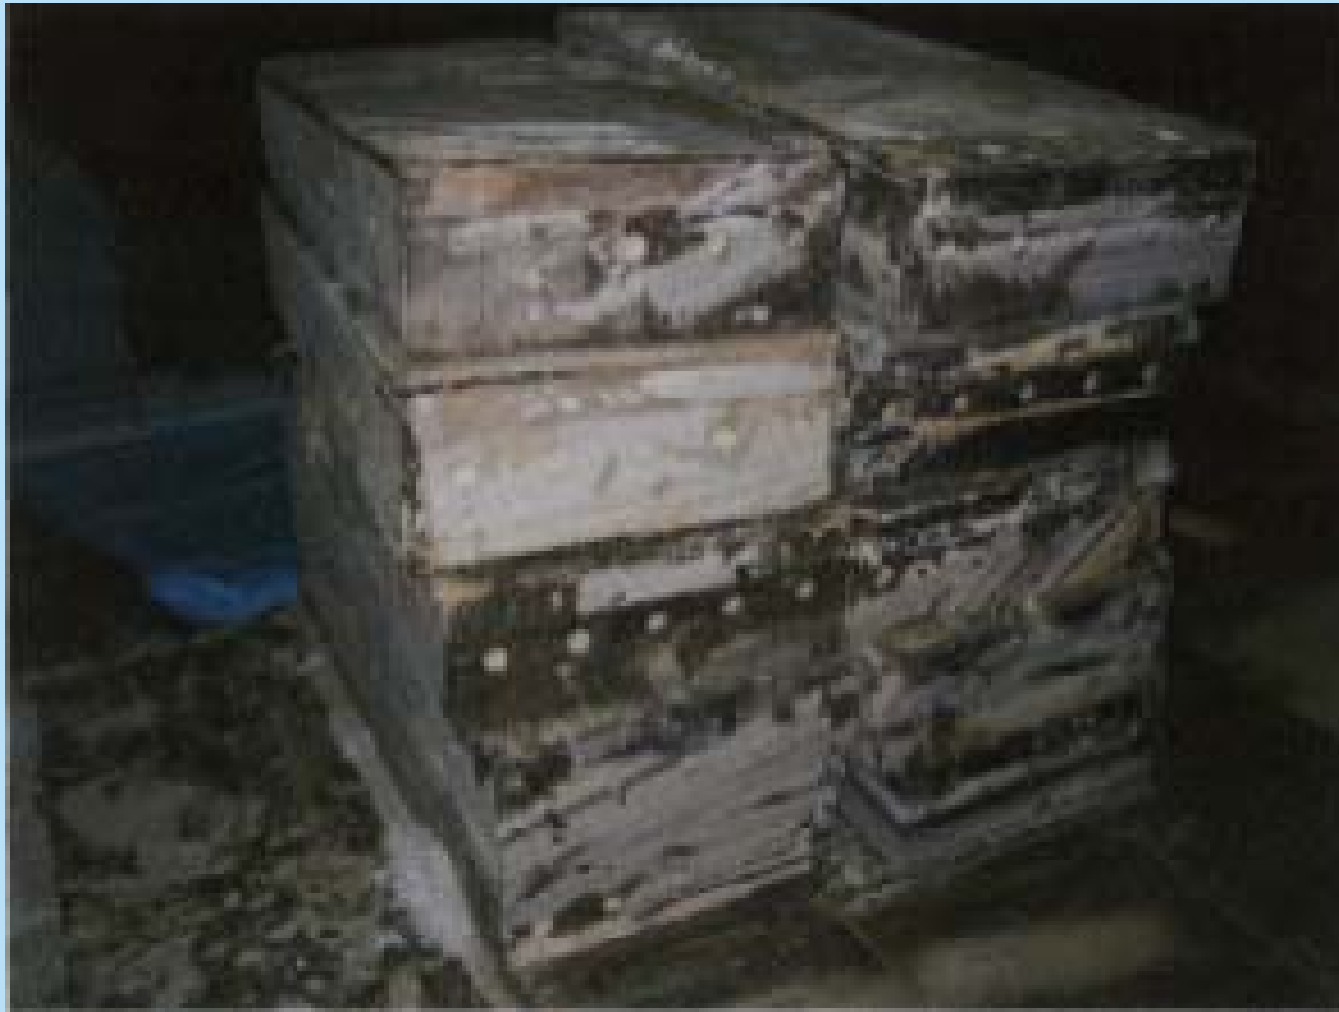
Resulting rust on the Primary and Secondary Invar Steel Membranes of the cargo tank after being soaked in seawater and moisture

Resulting primary and secondary insulation boxes soaked in seawater

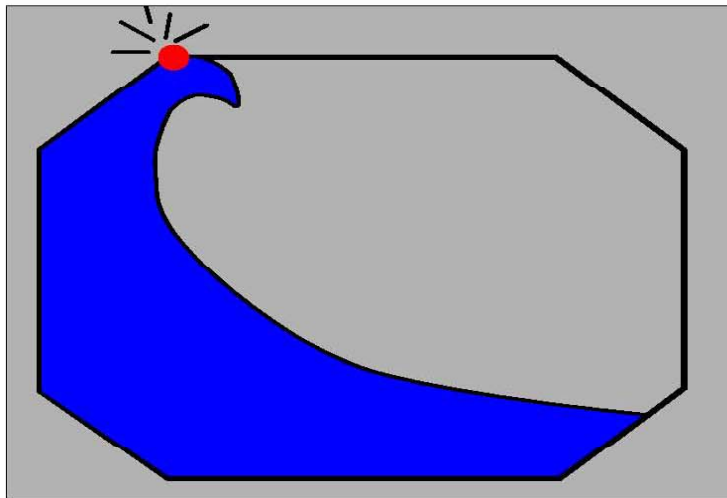
SLOSHING PHENOMENA

The sloshing phenomena occur when the ship motions coincide with the natural frequency of the liquid motion in the tanks. The build-up of violent motion is due to frequency, not amplitude.

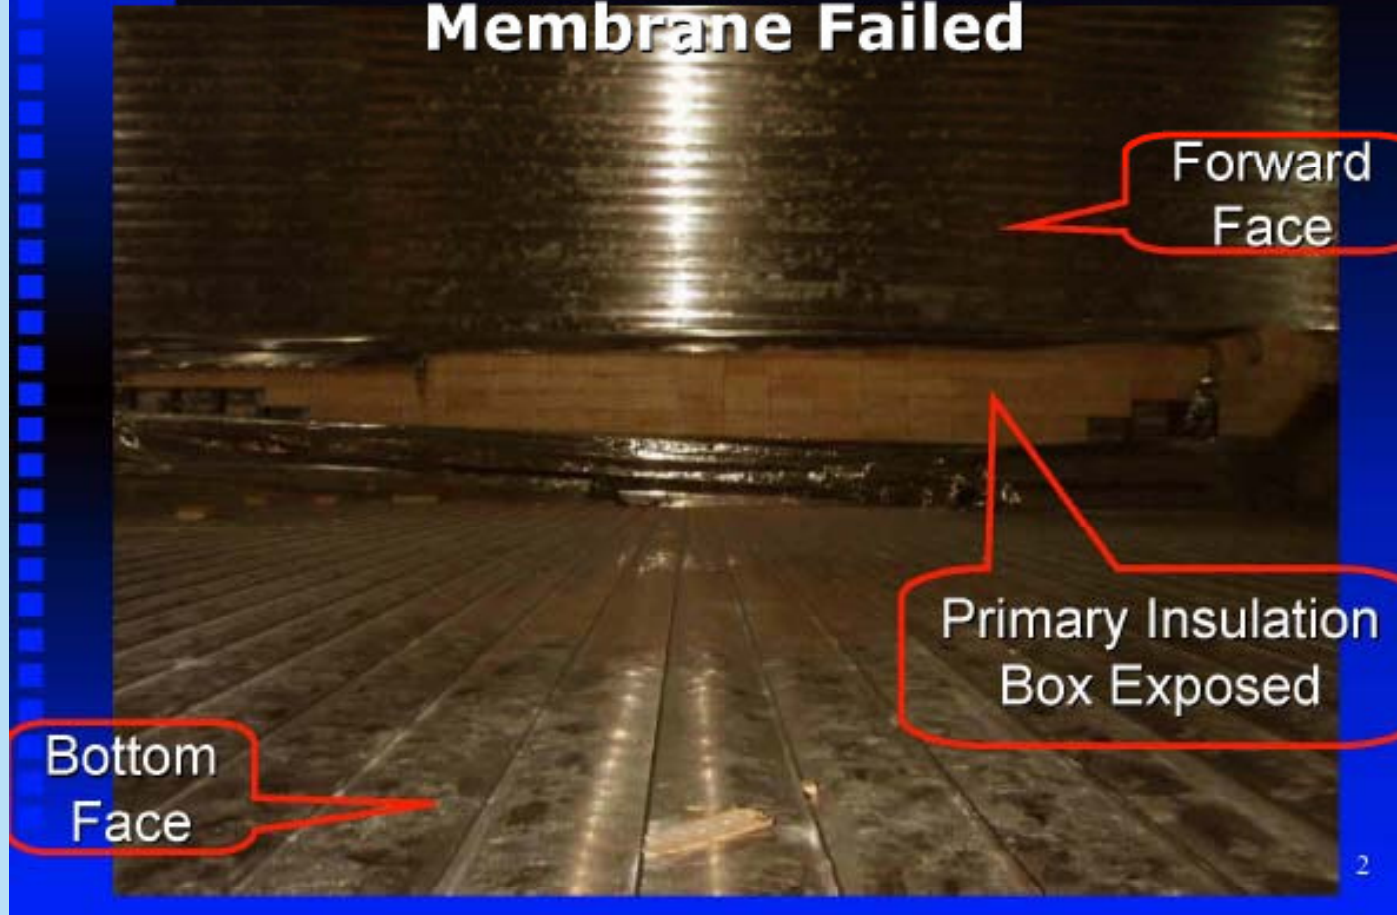
Looking Forward where the Membrane Failed

2005 LNG “X” Sloshing damage in an LNG tank due to heavy weather and being partially loaded— 6 months of repair and Millions of \$

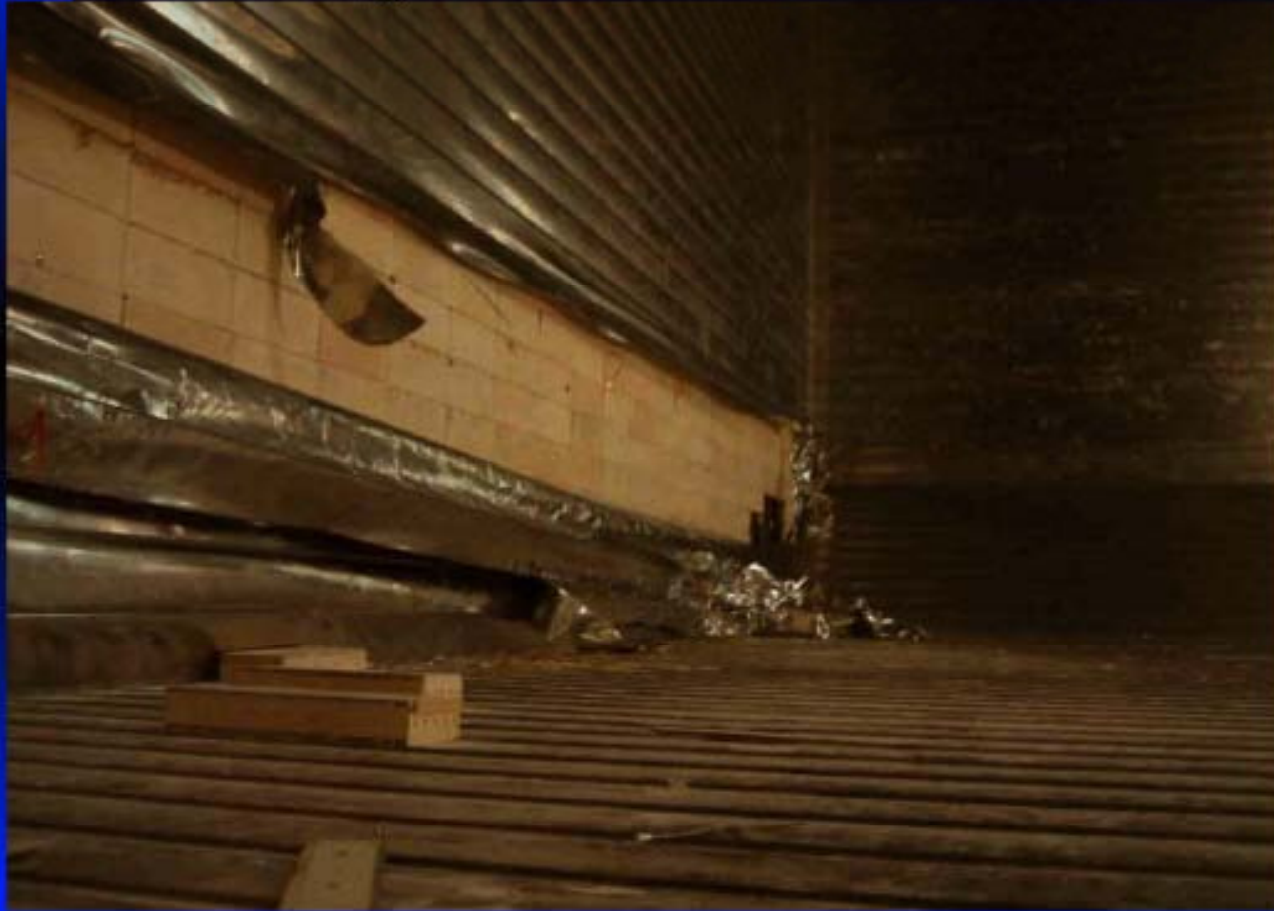
Looking Starboard from Port

Another close-up view of sloshing damage in a LNG tank

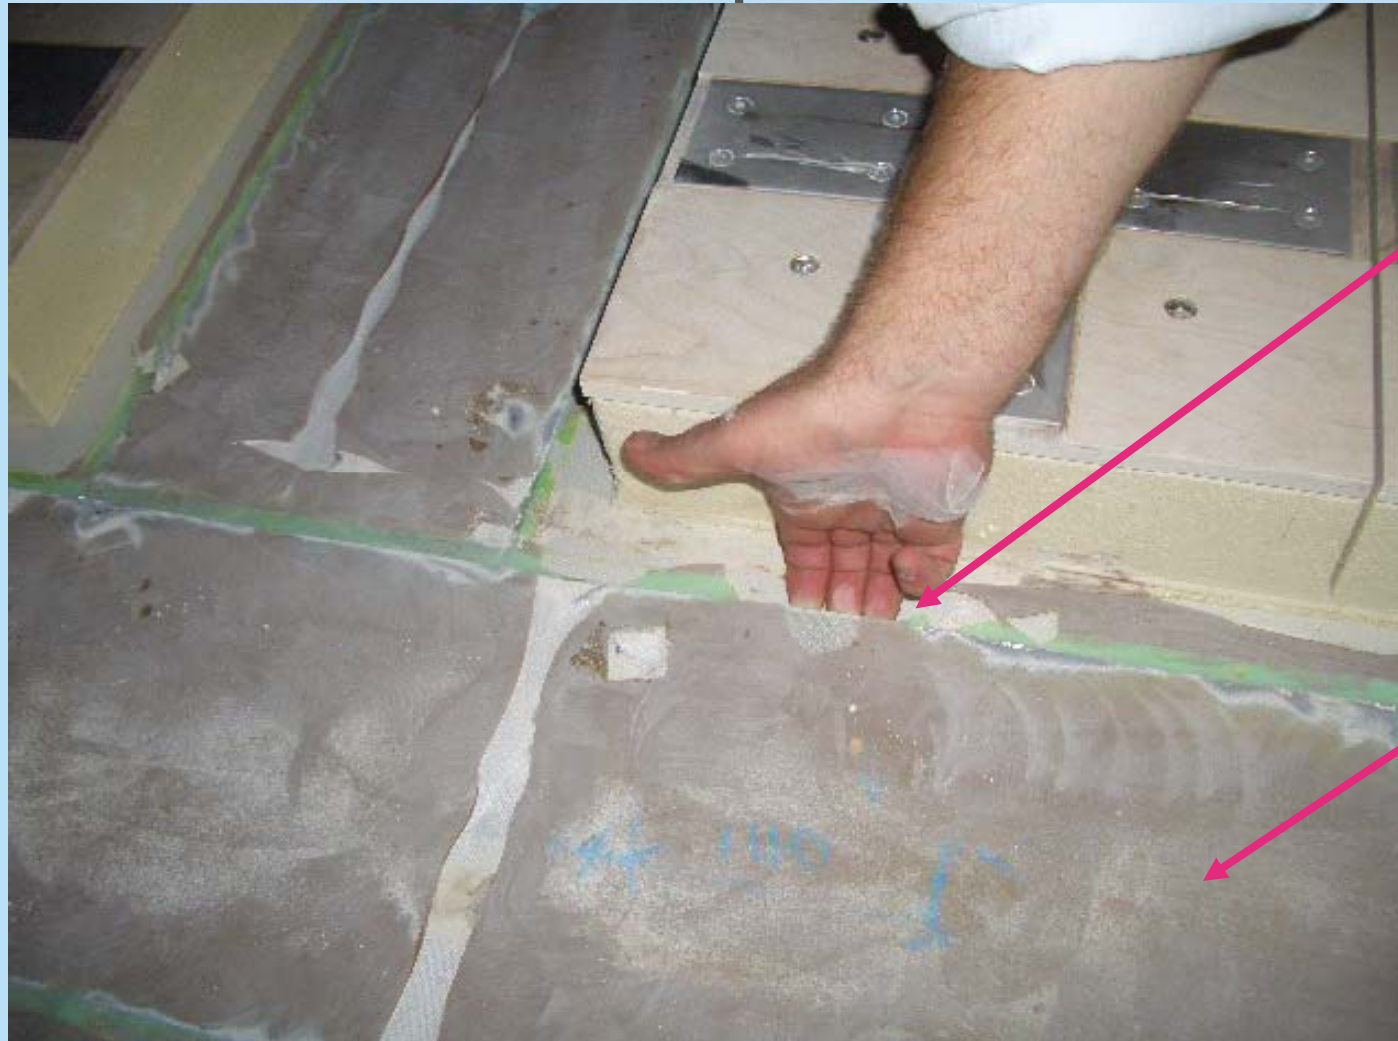
Secondary barrier leak “Triplex” Membrane failure on LNG Carriers in Operations (N2 leak detected during operations) Two Months or More of Repair Period

Separation
due to
failure of
“Glue”

“Triplex”
Membrane-
made of
(glass cloth/
Aluminum
foil/ glass
cloth) as
secondary
barrier

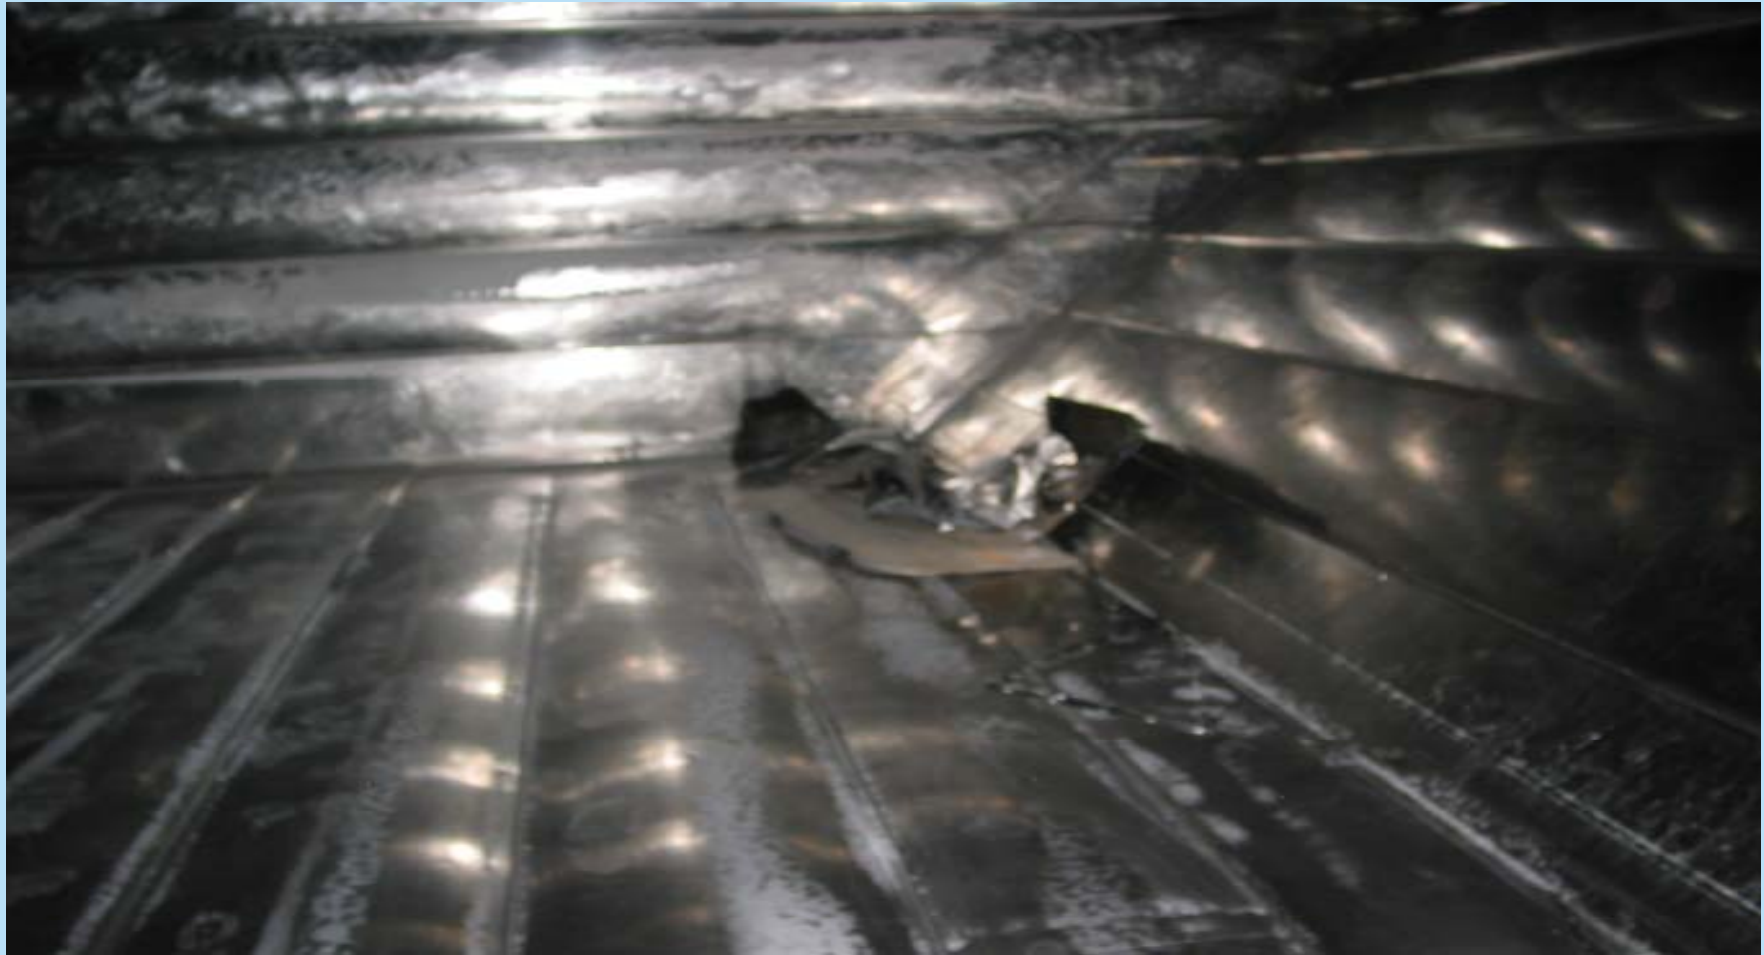
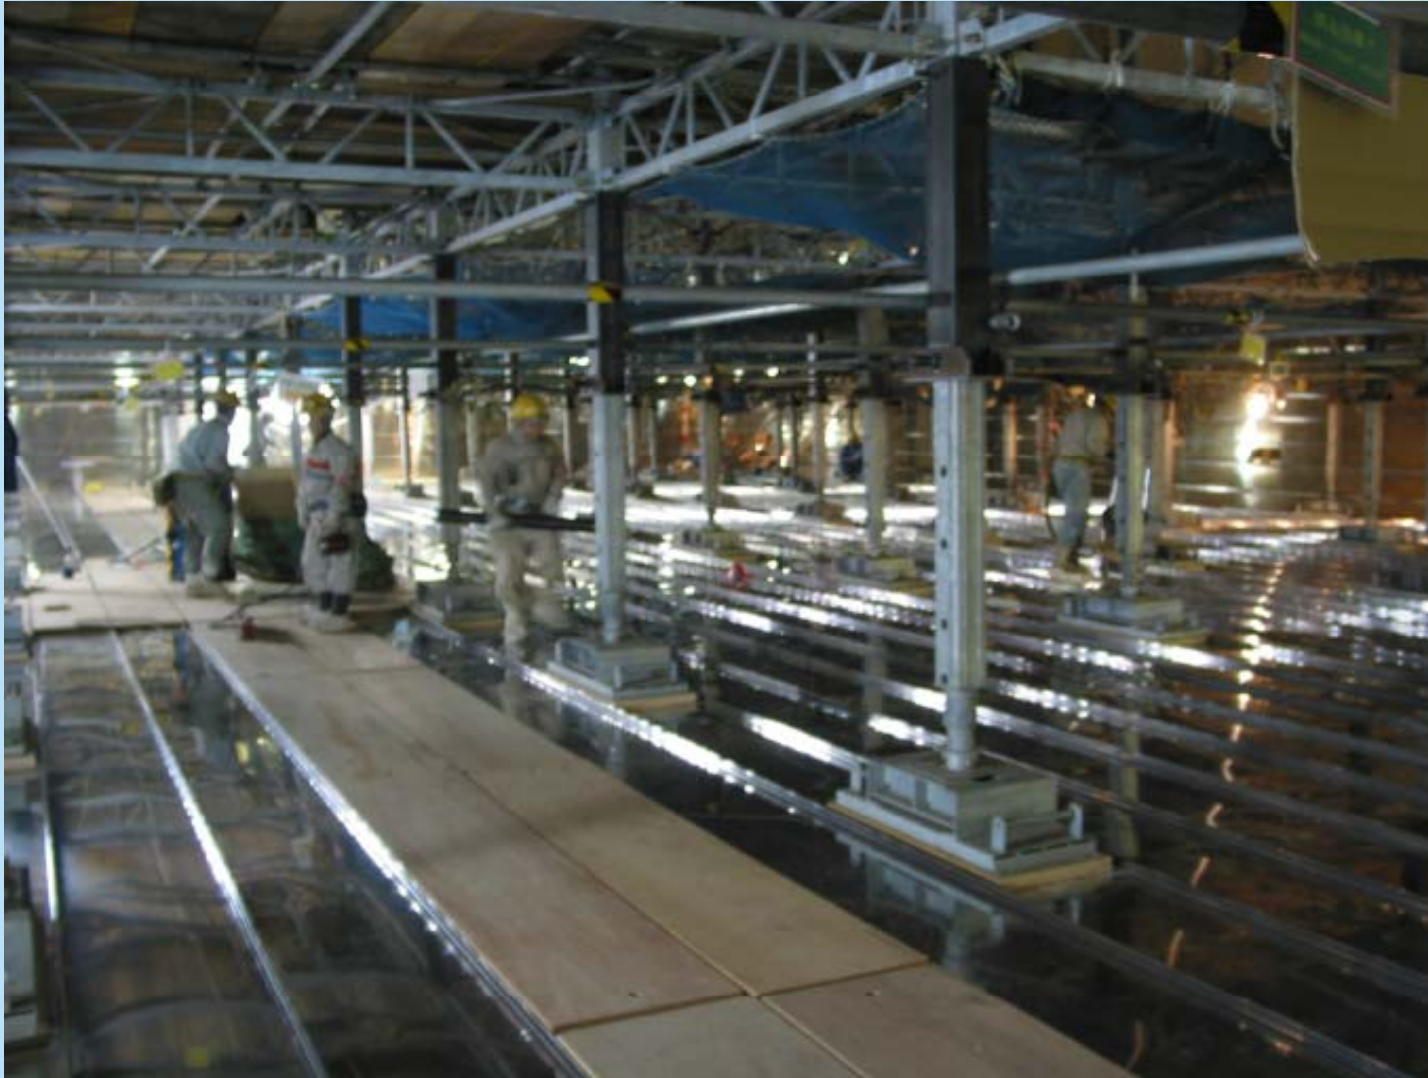
Bulging of Invar Membrane of LNG Carrier during Testing at Construction or After Repair

Special staging (12 levels) from bottom to top of a cargo tank for repairs (thousands of pieces of special stage materials similar to the staging in building construction)

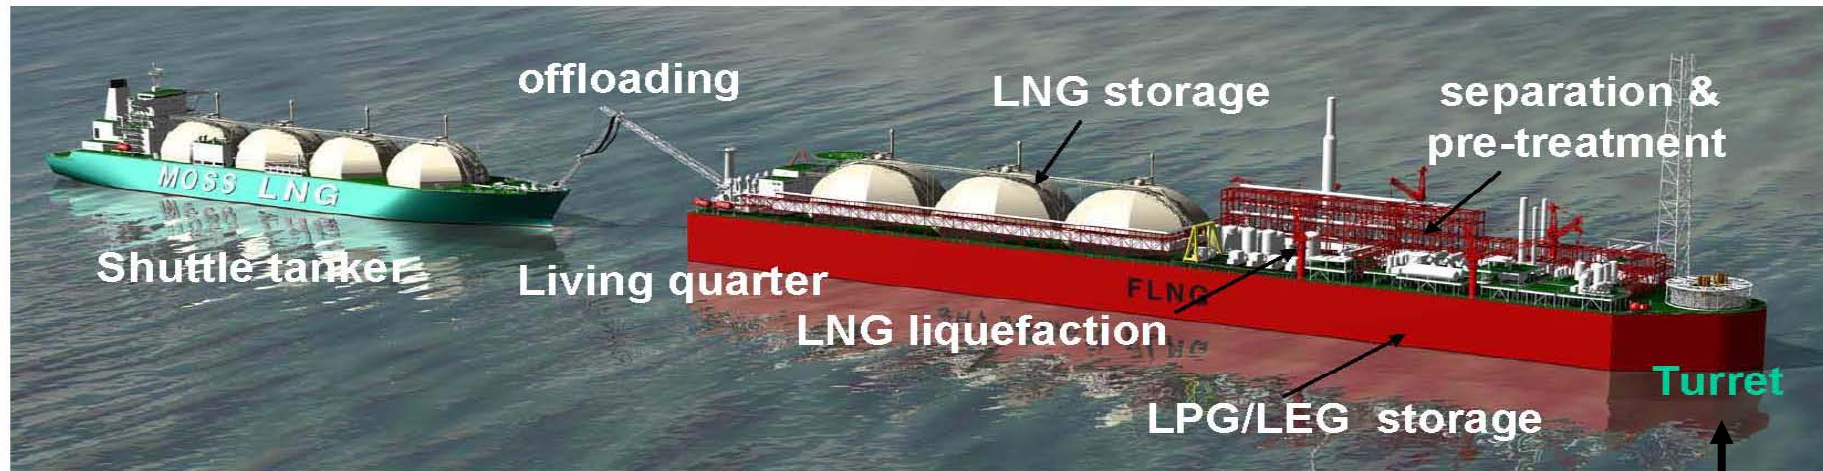
New Technology: LNG FPSO - Floating Production Storage Offloading (Under Design/ Construction Stage for Smaller Reserves)

LNG storage : 180 - 250,000 m³
LNG production: 2 - 5 MMTPA/
290 - 730 MSCFD

Length: 300 - 450 m
Breadth: 50 - 70 m
Design life: 40 years
