Risk Assessment & Loss Prevention for LNG Ships

K.S. Wang
Principal Surveyor for Japan

Loss Prevention through Risk Assessment Surveys of LNG Carriers

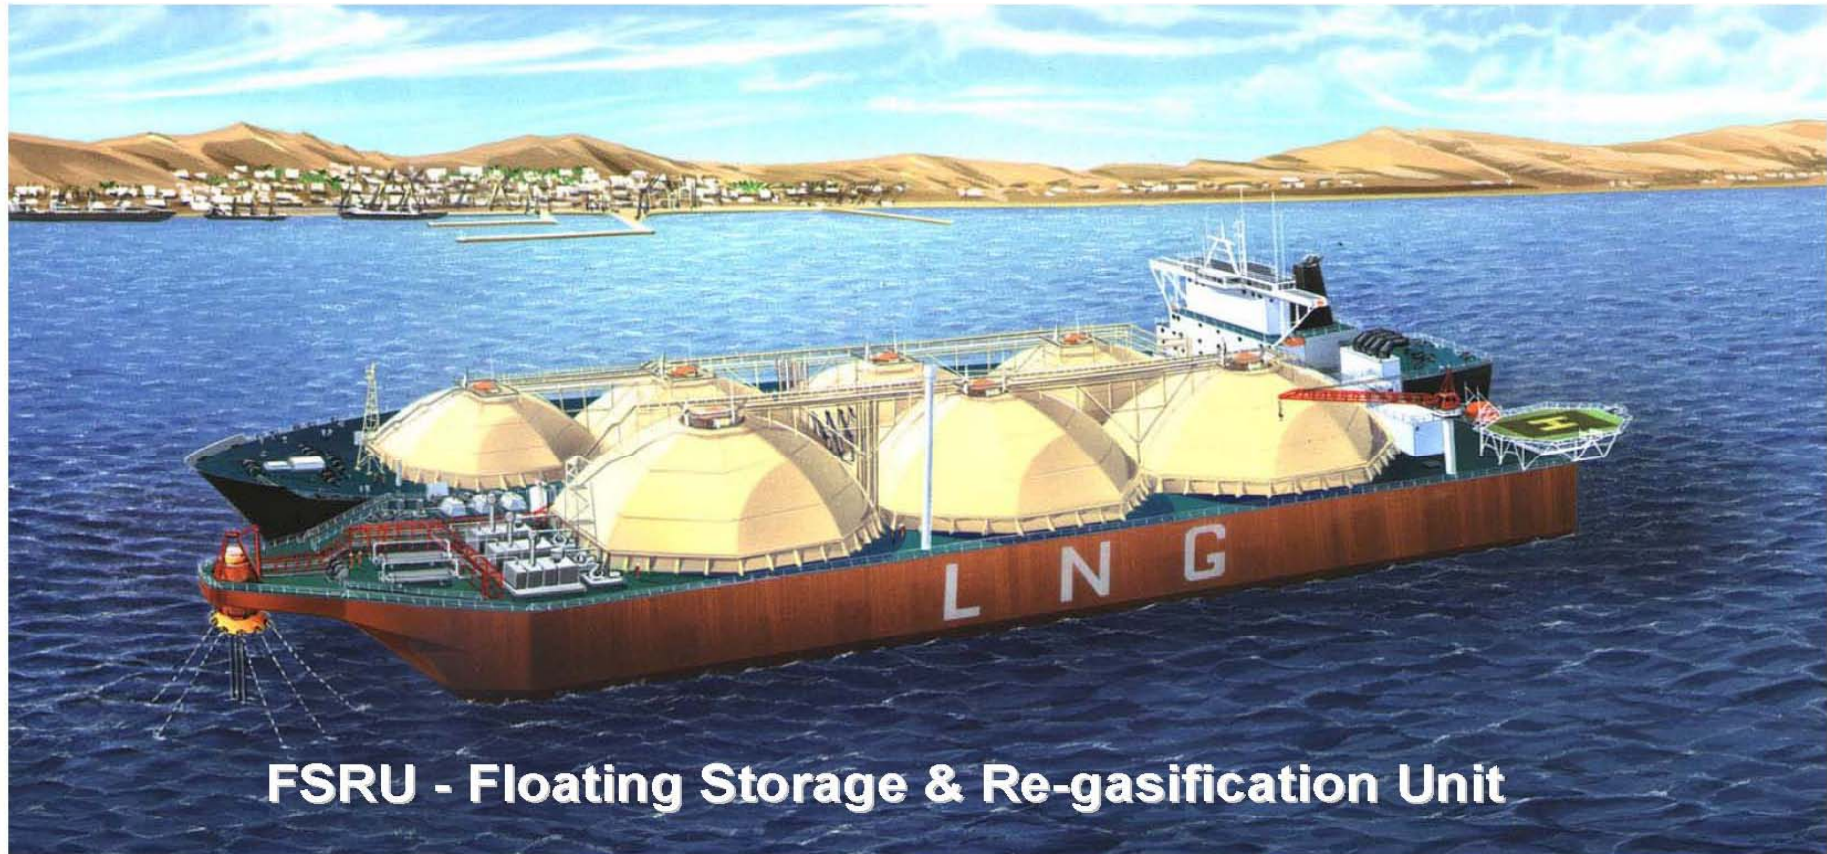
New: LNG FSRU (In Operation, Under Conversion and Construction)

- New construction of LNG FSRU
- Conversion from existing LNG Carrier in Sembawang Shipyard
- No. of Crew on board: About 30
- Life Span: About 40 years
- Temporary Sites
